Manual for Dismantling, Documenting and Rebuilding Historic Tiled Stoves

—Sustainable Heritage Report No. 3

A joint project between Gotland University, Estonian Academy of Arts
and Novia University of Applied Sciences.

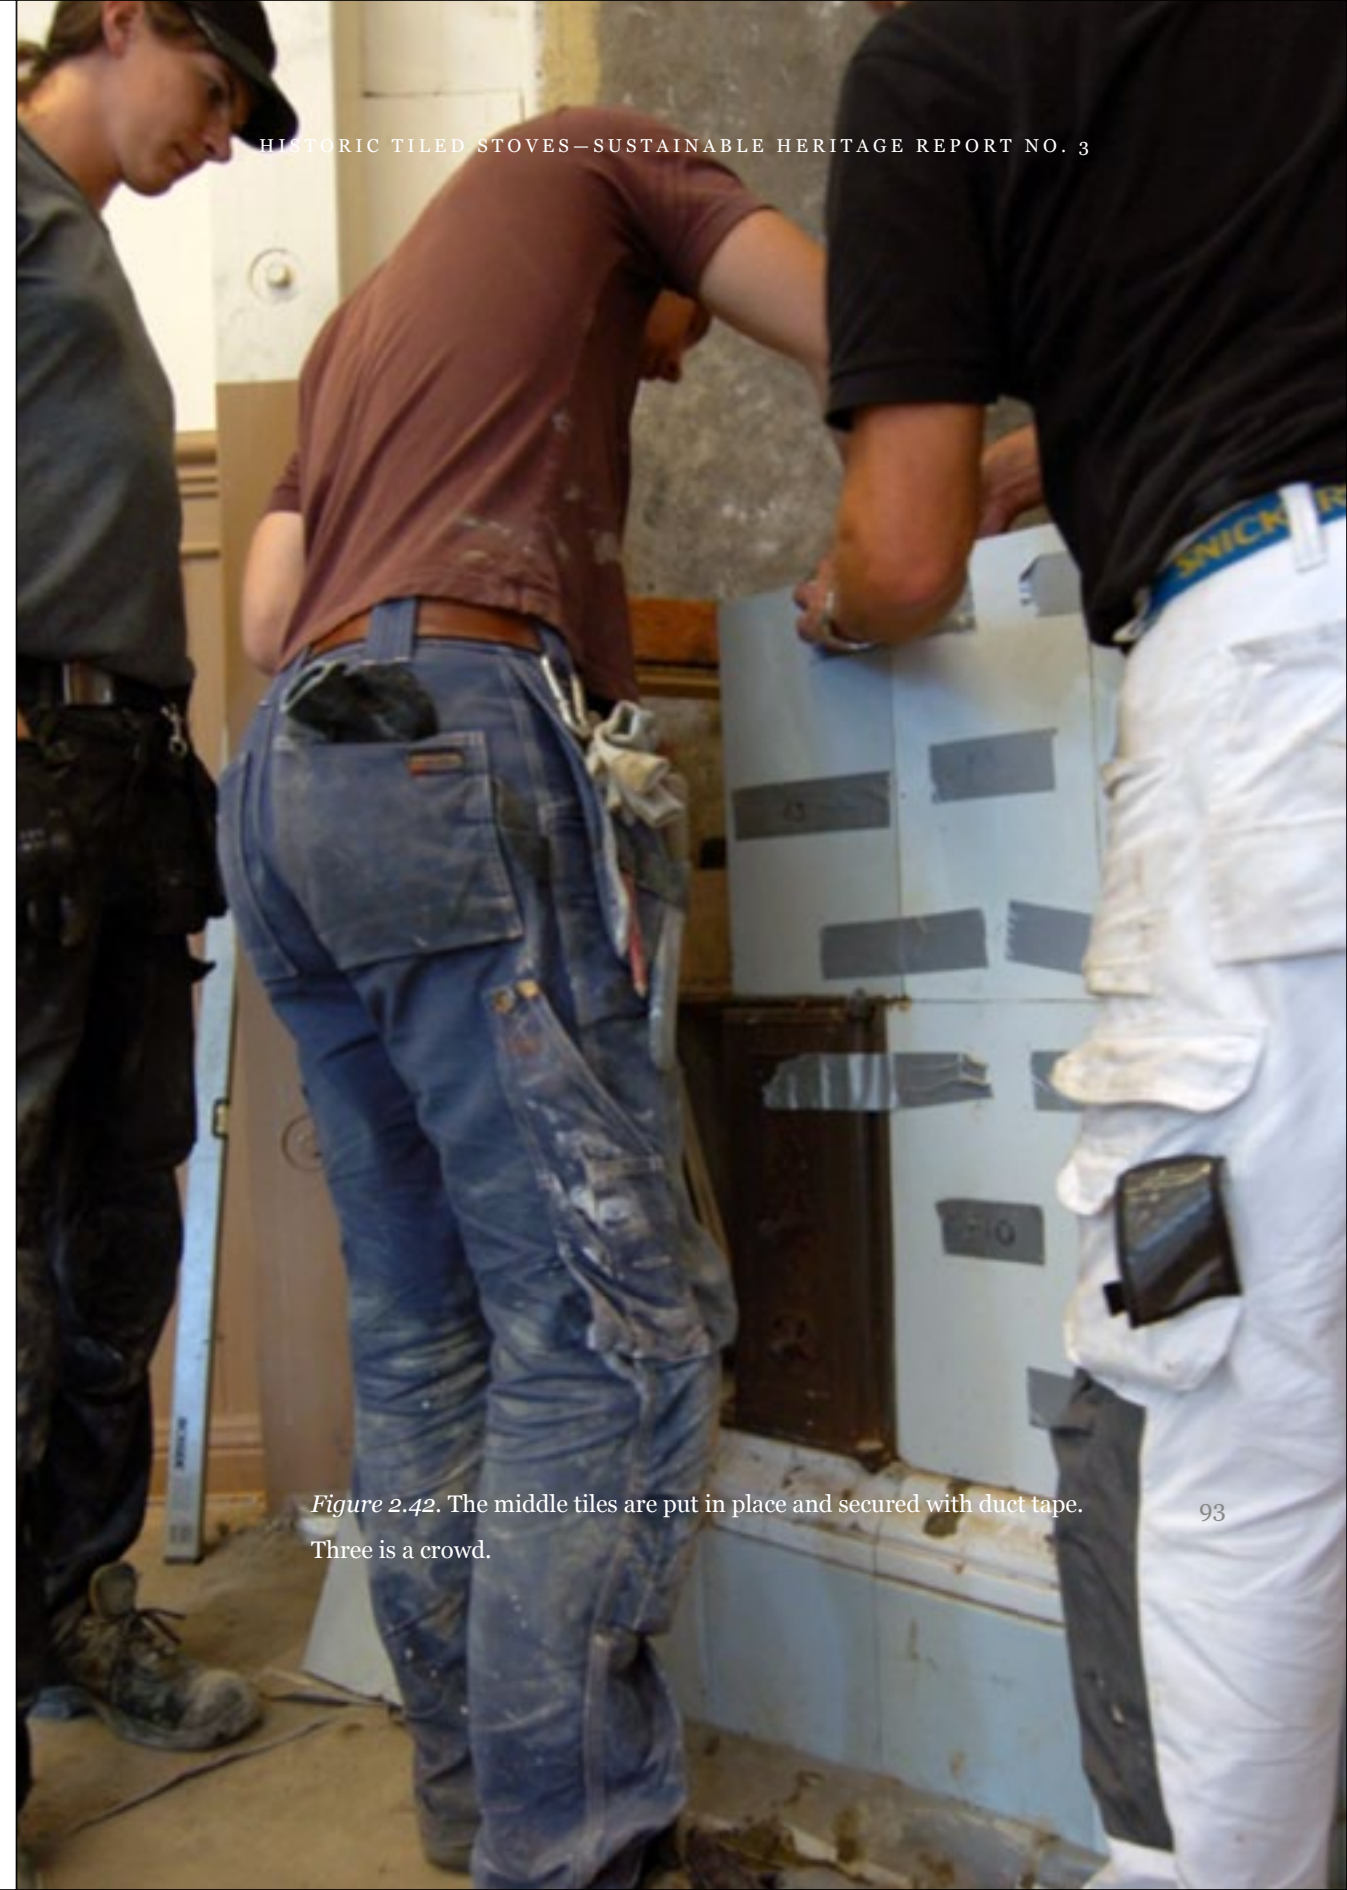
Figure 2.42. The middle tiles are put in place and secured with duct tape. Three is a crowd.

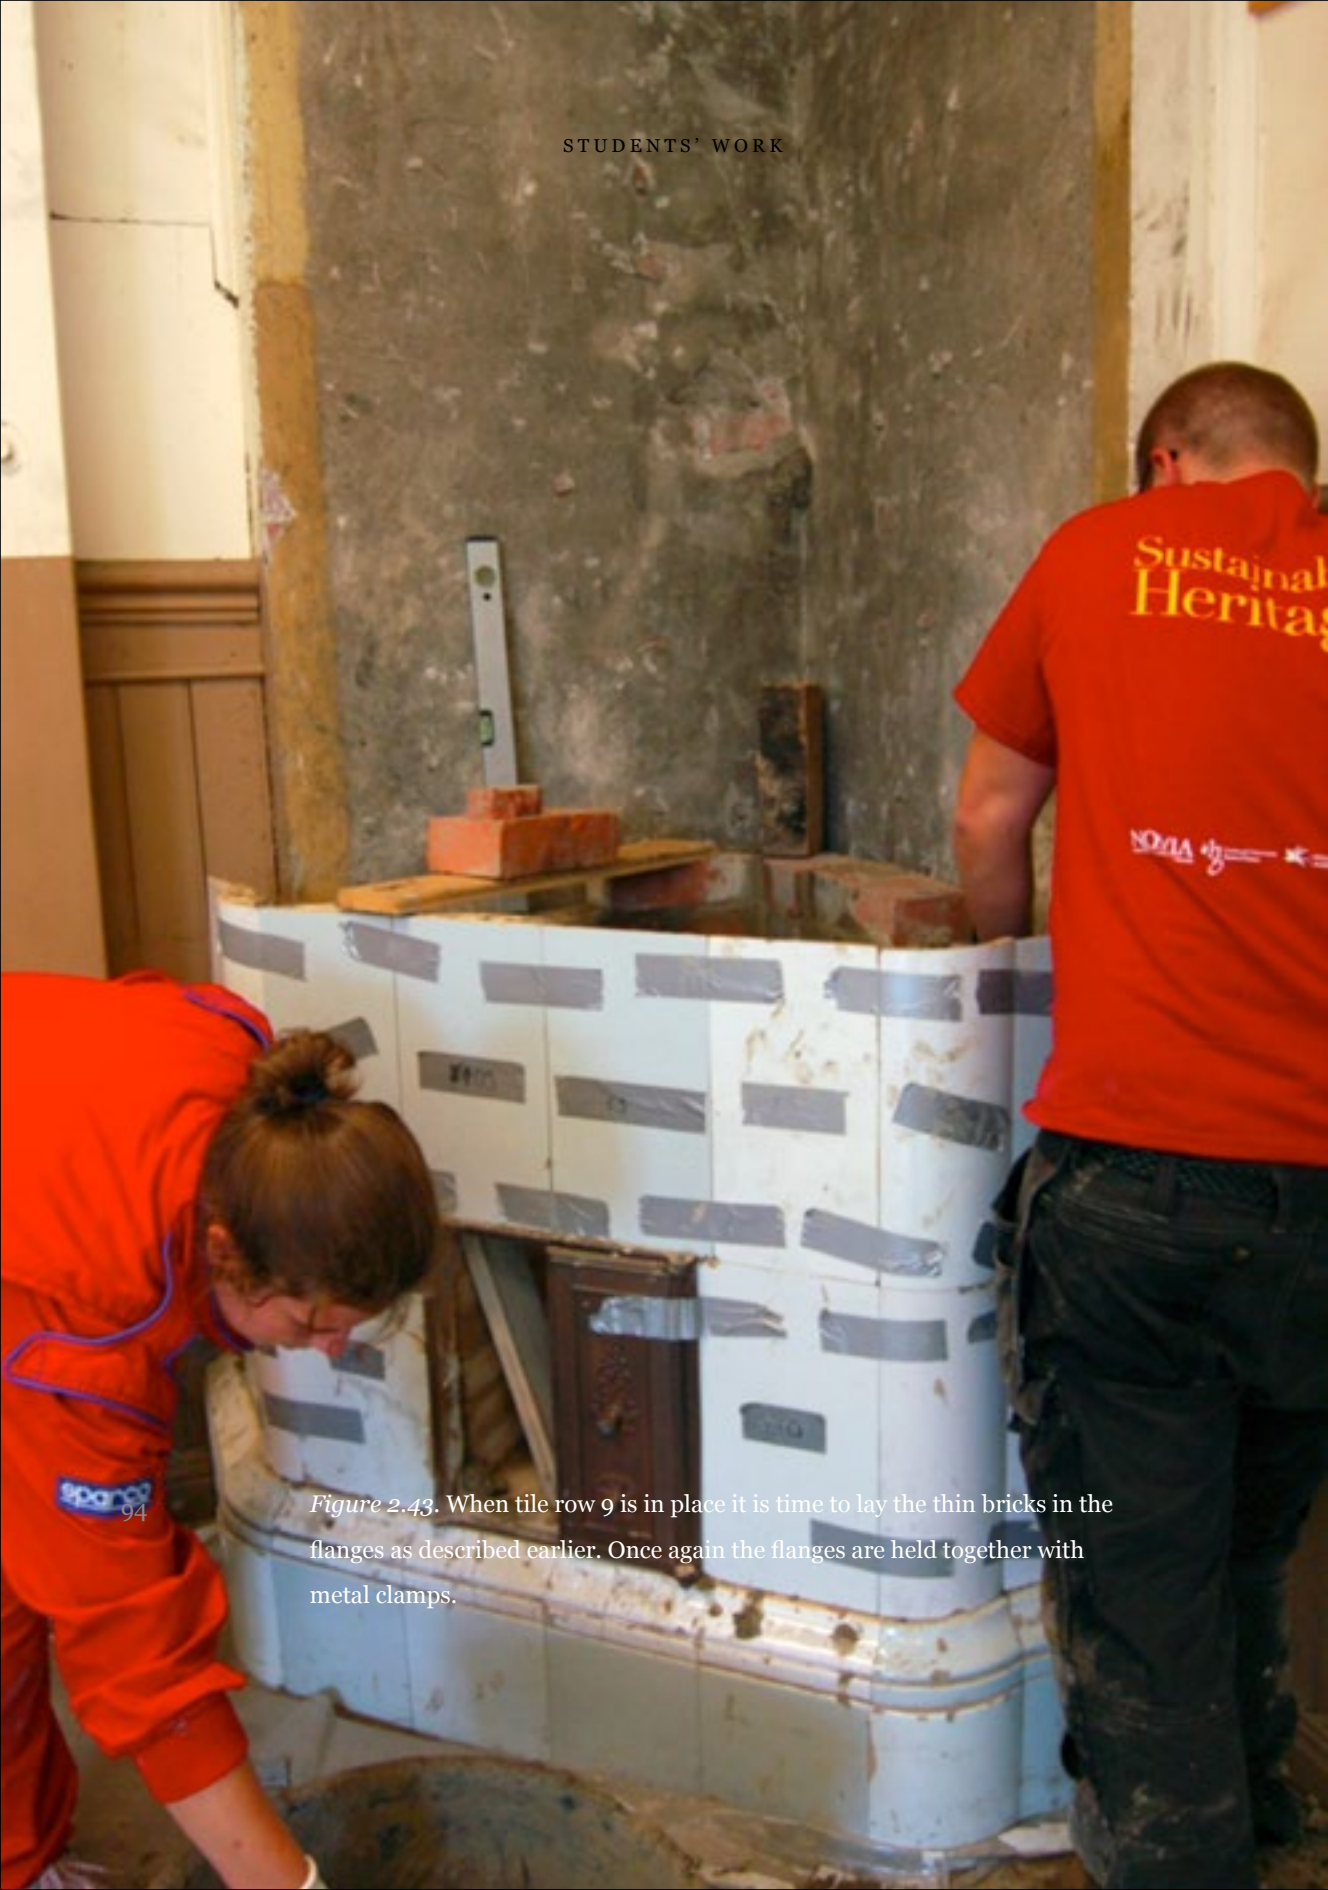
Figure 2.43. When tile row 9 is in place it is time to lay the thin bricks in the flanges as described earlier. Once again the flanges are held together with metal clamps.

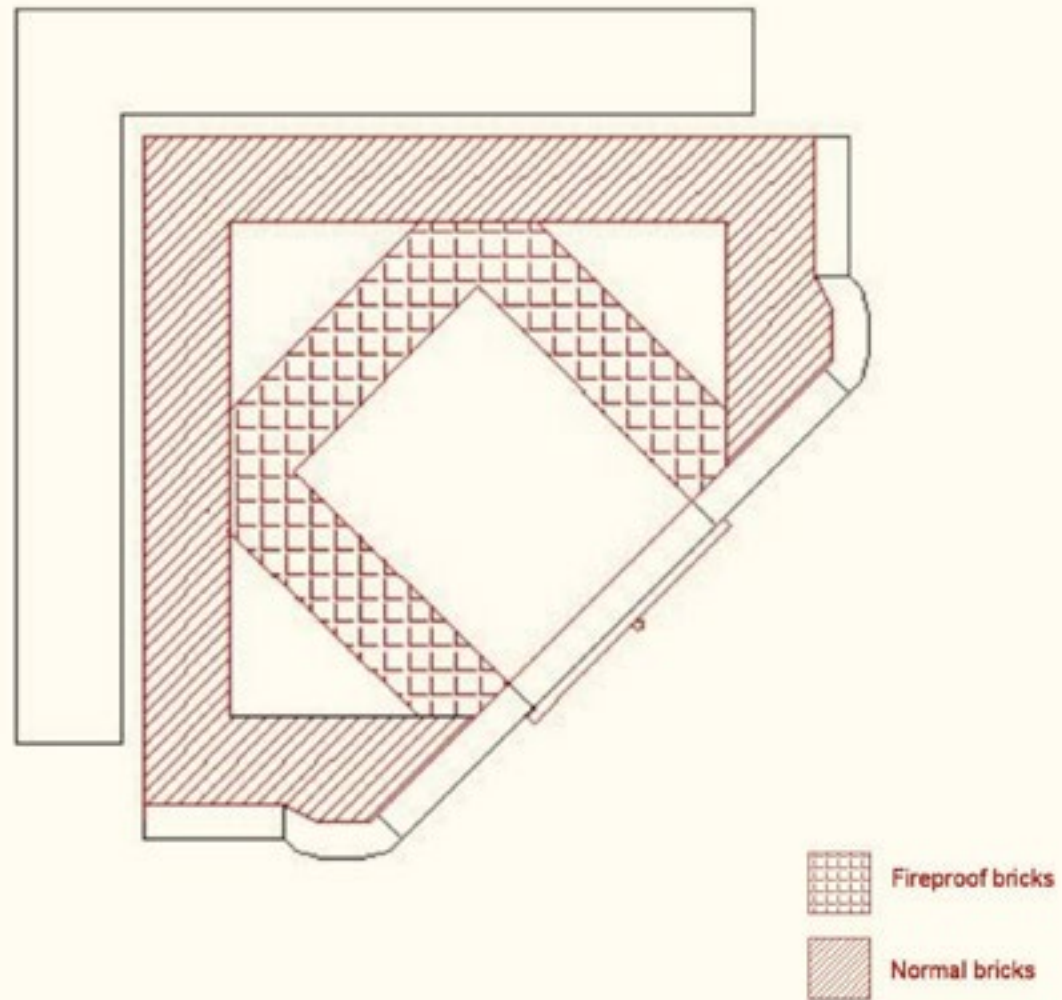
Figure 2.61. Tile row 10: square furnace in the middle; side flues meet underneath the furnace and lead to the flue in the back which leads to the chimney at the top.

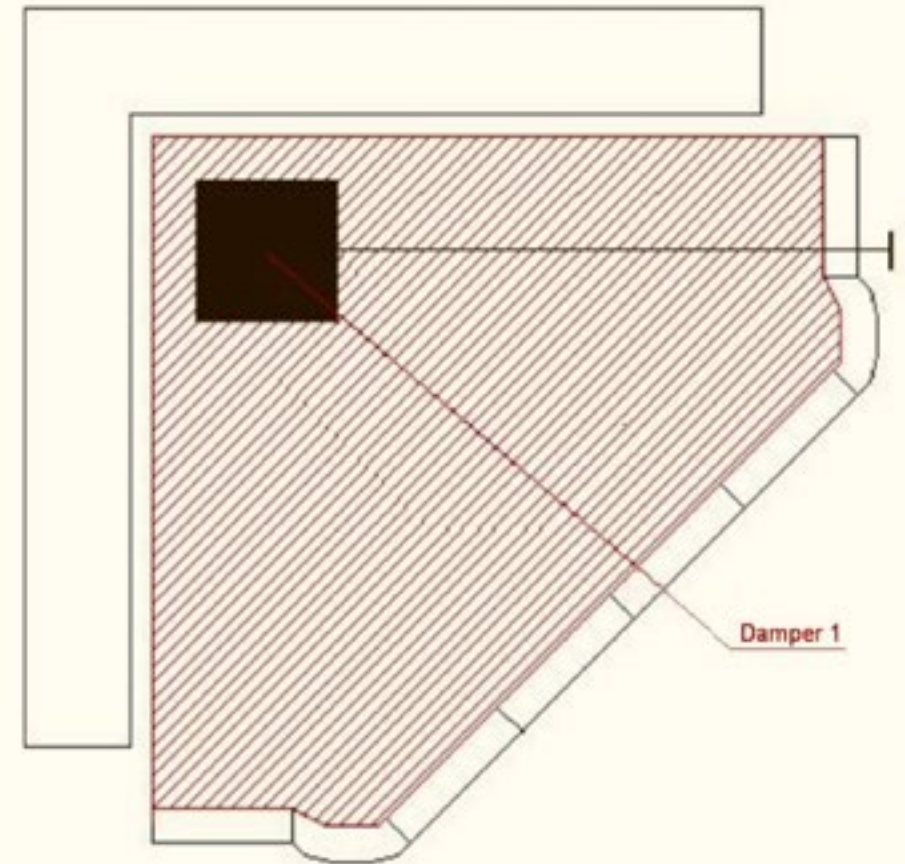
Figure 2.68. Tile row 3, brick row B: the top is closed by a layer of bricks below this level. Smoke from the furnace is lead down to the side flues. The chimney can be closed with a damper.

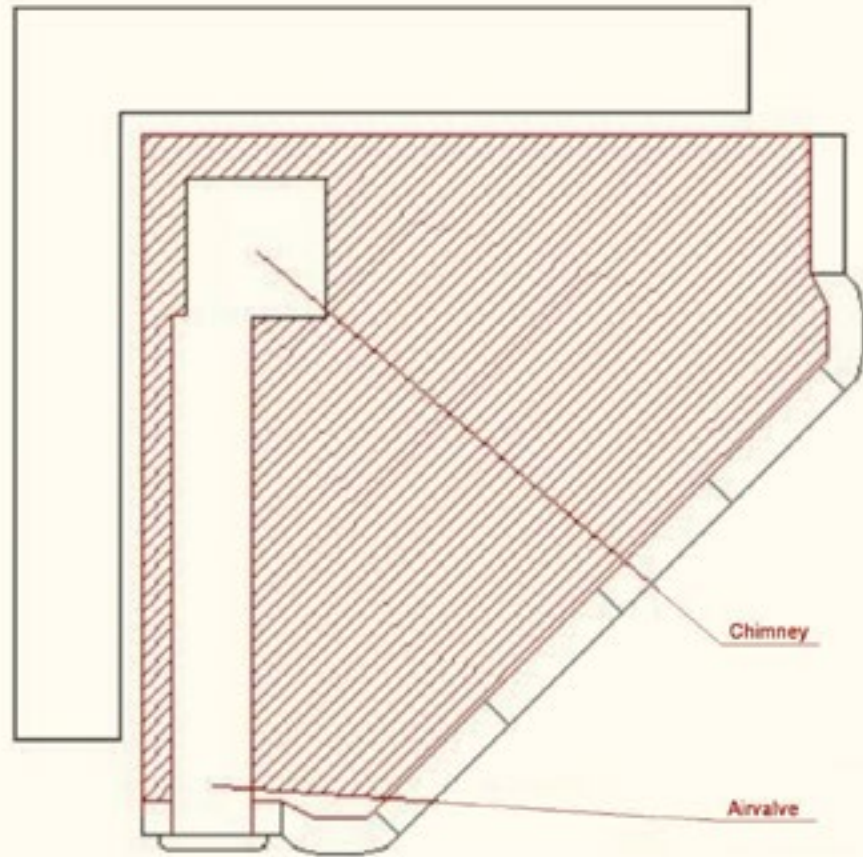
Figure 2.69. Tile row 3, brick row C: between the two dampers there is an air duct for ventilation.
